ROLL-LOK CLEATED EAVE  
ON FRAMING

DWG NO: RL.1.B.1

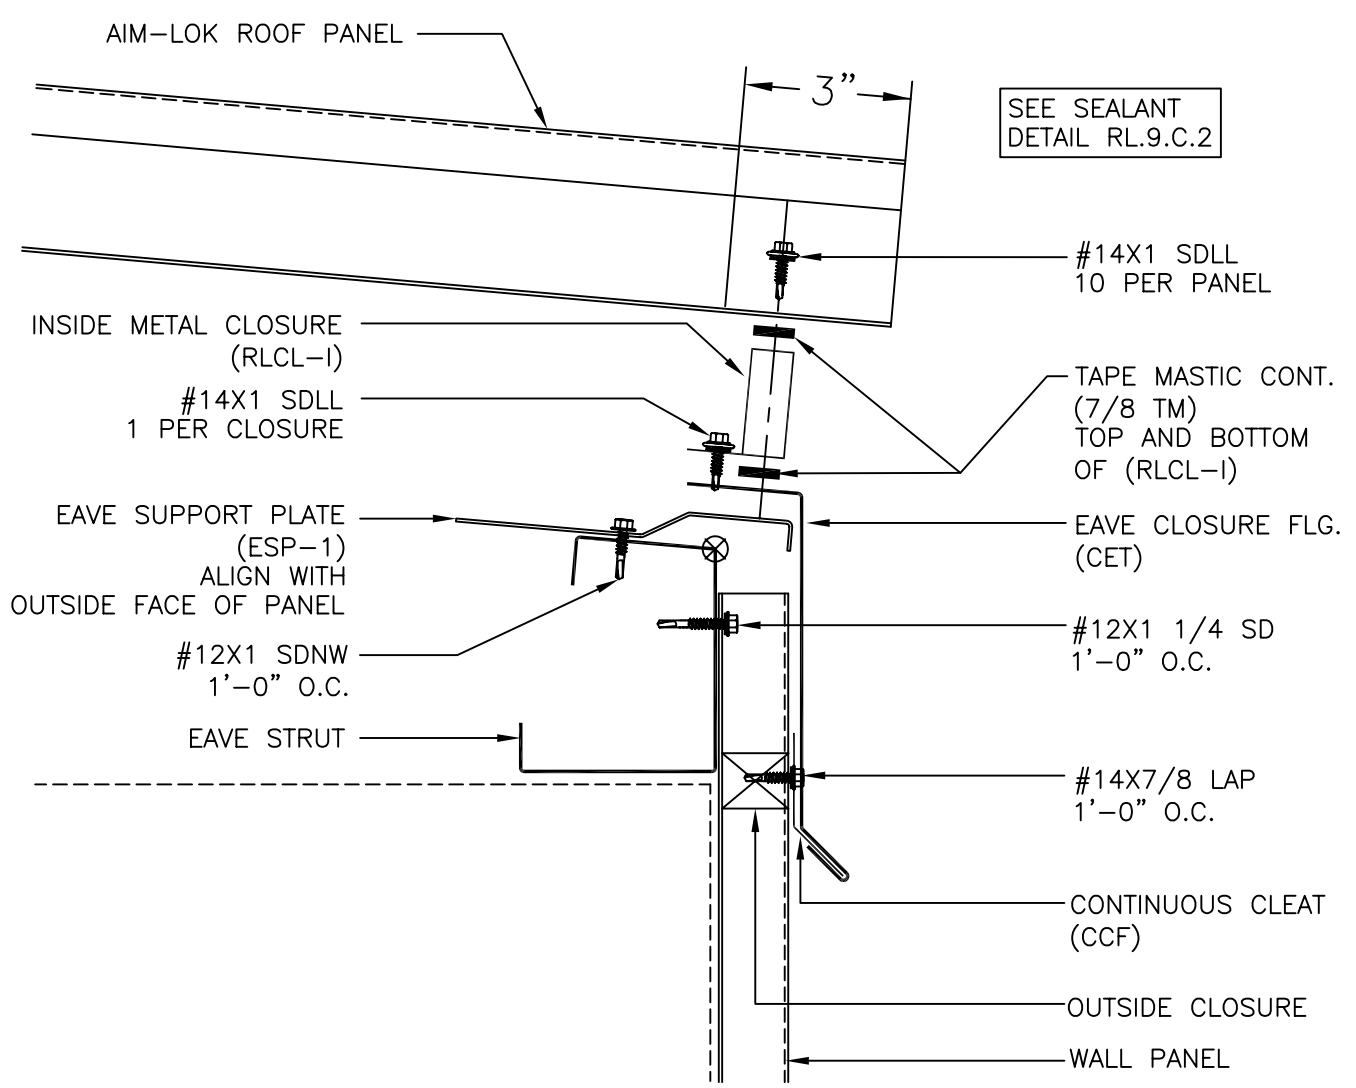
SEE SEALANT  
DETAIL RL.9.C.2
