SNAP-SEAM CLEATED
RAKE (ENDING)
ON FRAMING

DWG NO: SS.2.A.2

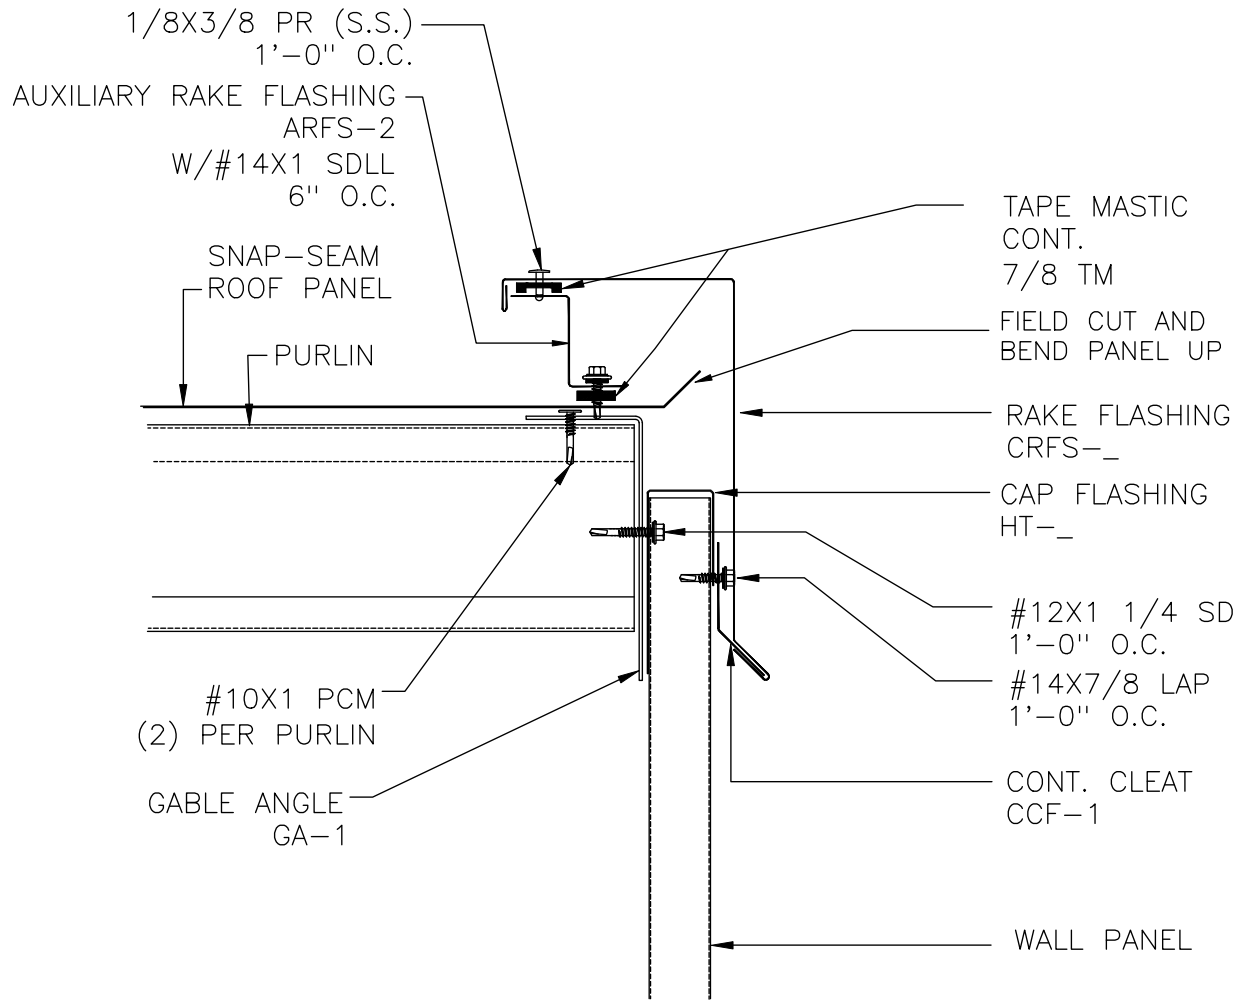
12
SLOPE 3
MIN.

CLEATED RAKE ON FRAMING (ENDING)
SNAP-SEAM ROOF PANEL WITH WALL PANEL (PINNED CONDITION)
