SNAP-SEAM ROOF PANEL WITH WALL PANEL (FLOATING CONDITION)

SNAP-SEAM CLEATED  
RAKE (ENDING)  
ON FRAMING

DWG NO: SS.2.B.2

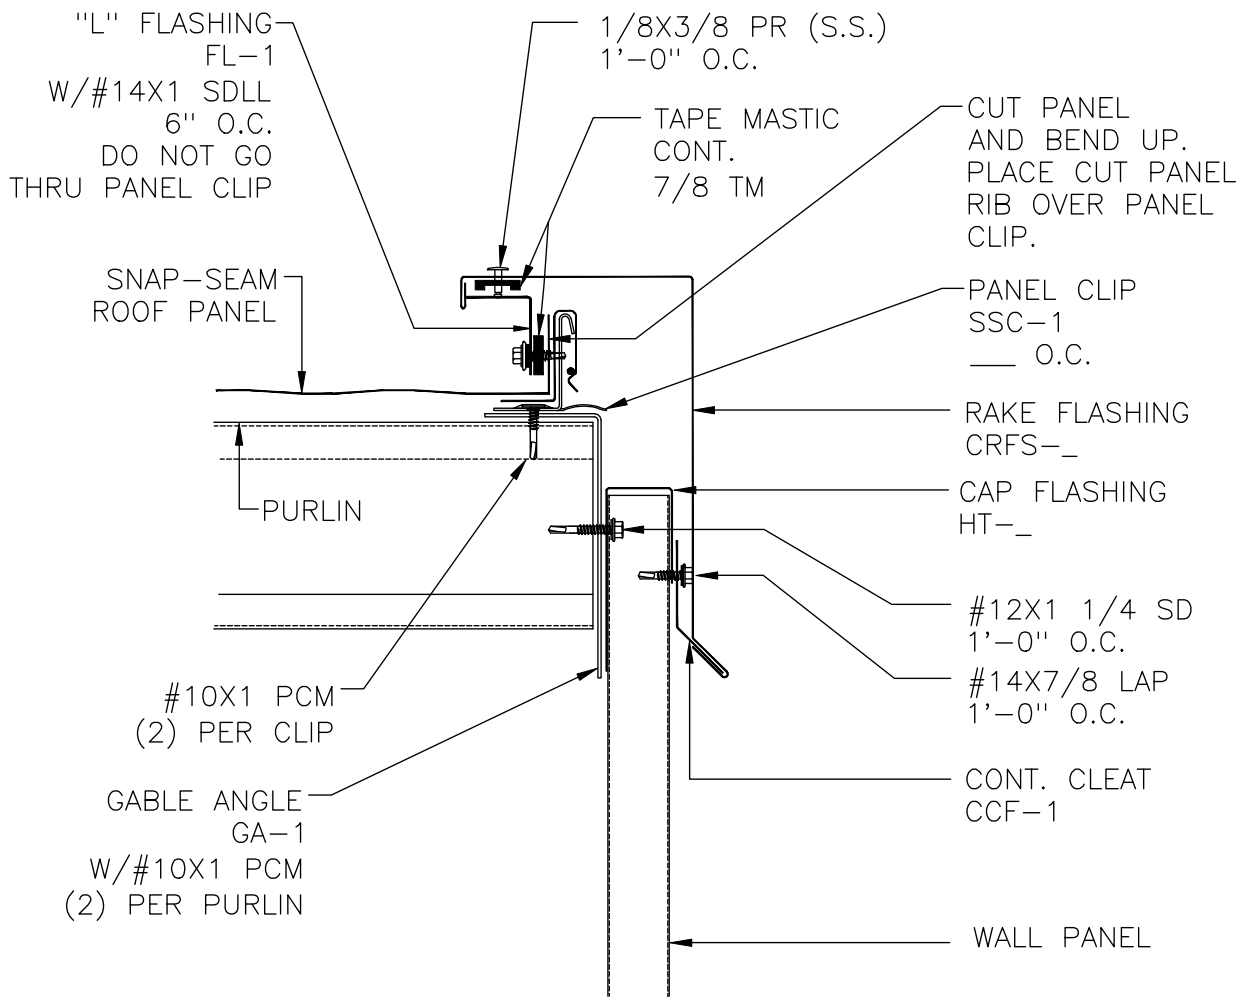
CLEATED RAKE ON FRAMING (ENDING)
